# METEOROID AND DEBRIS IMPACT FEATURES DOCUMENTED ON THE LONG DURATION EXPOSURE FACILITY

## A Preliminary Report

Compiled by Members  
of the LDEF Meteoroid  
and Debris Special  
Investigation Group

August 1990

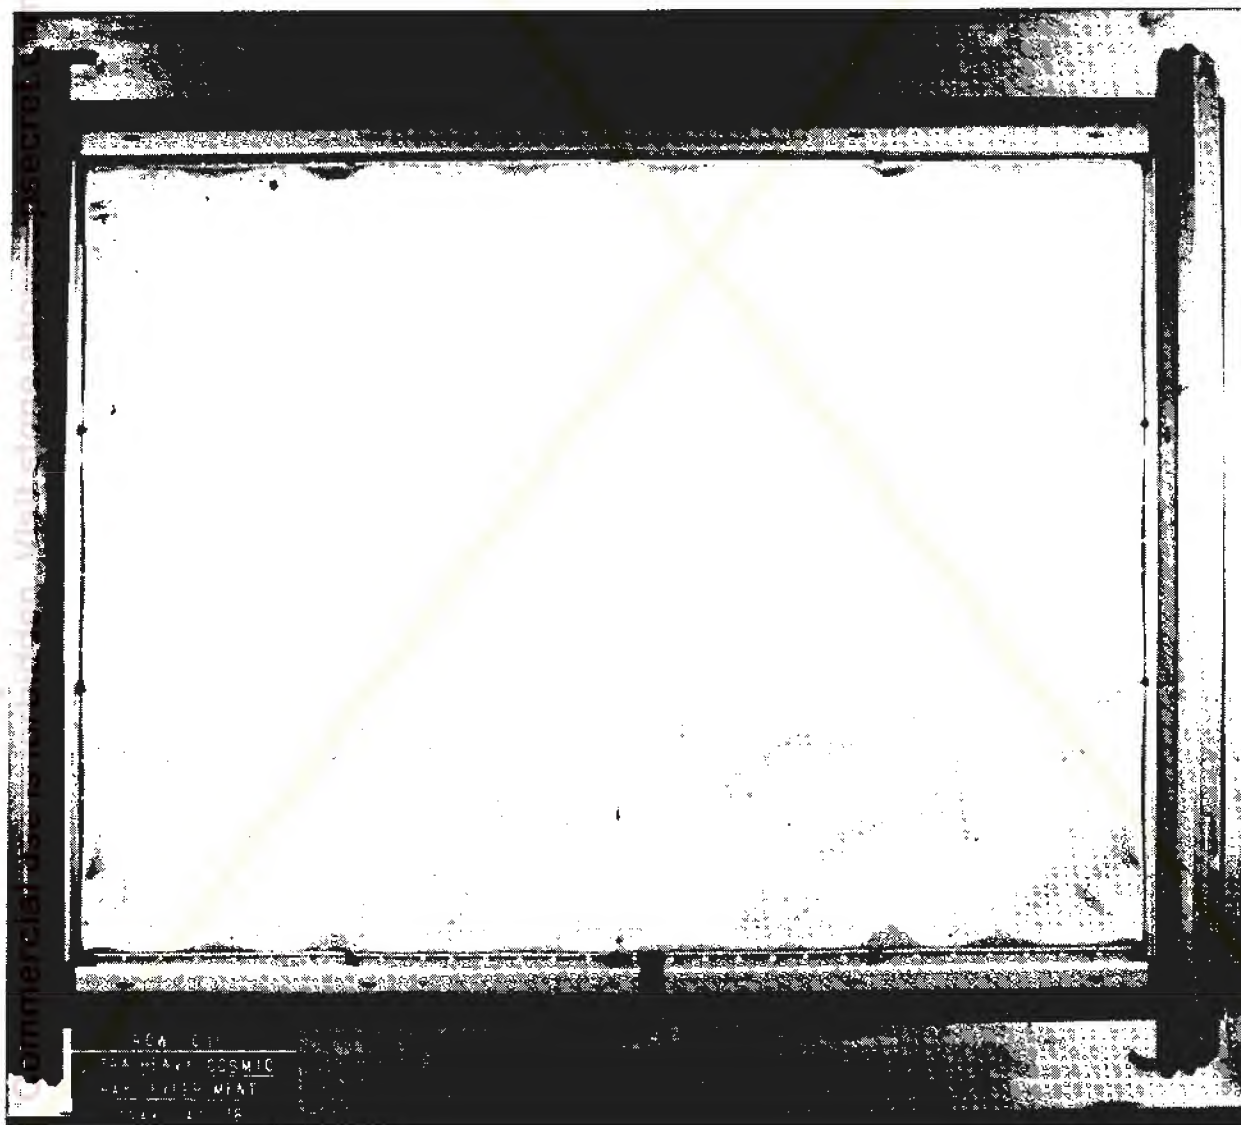
**Figure C11-1.** This post-deintegration view shows the front of the entire C11 experiment thermal blanket. Oxygen erosion has given the blanket a frosted appearance. The double impact feature in the center of the blanket is shown in Figure C11.

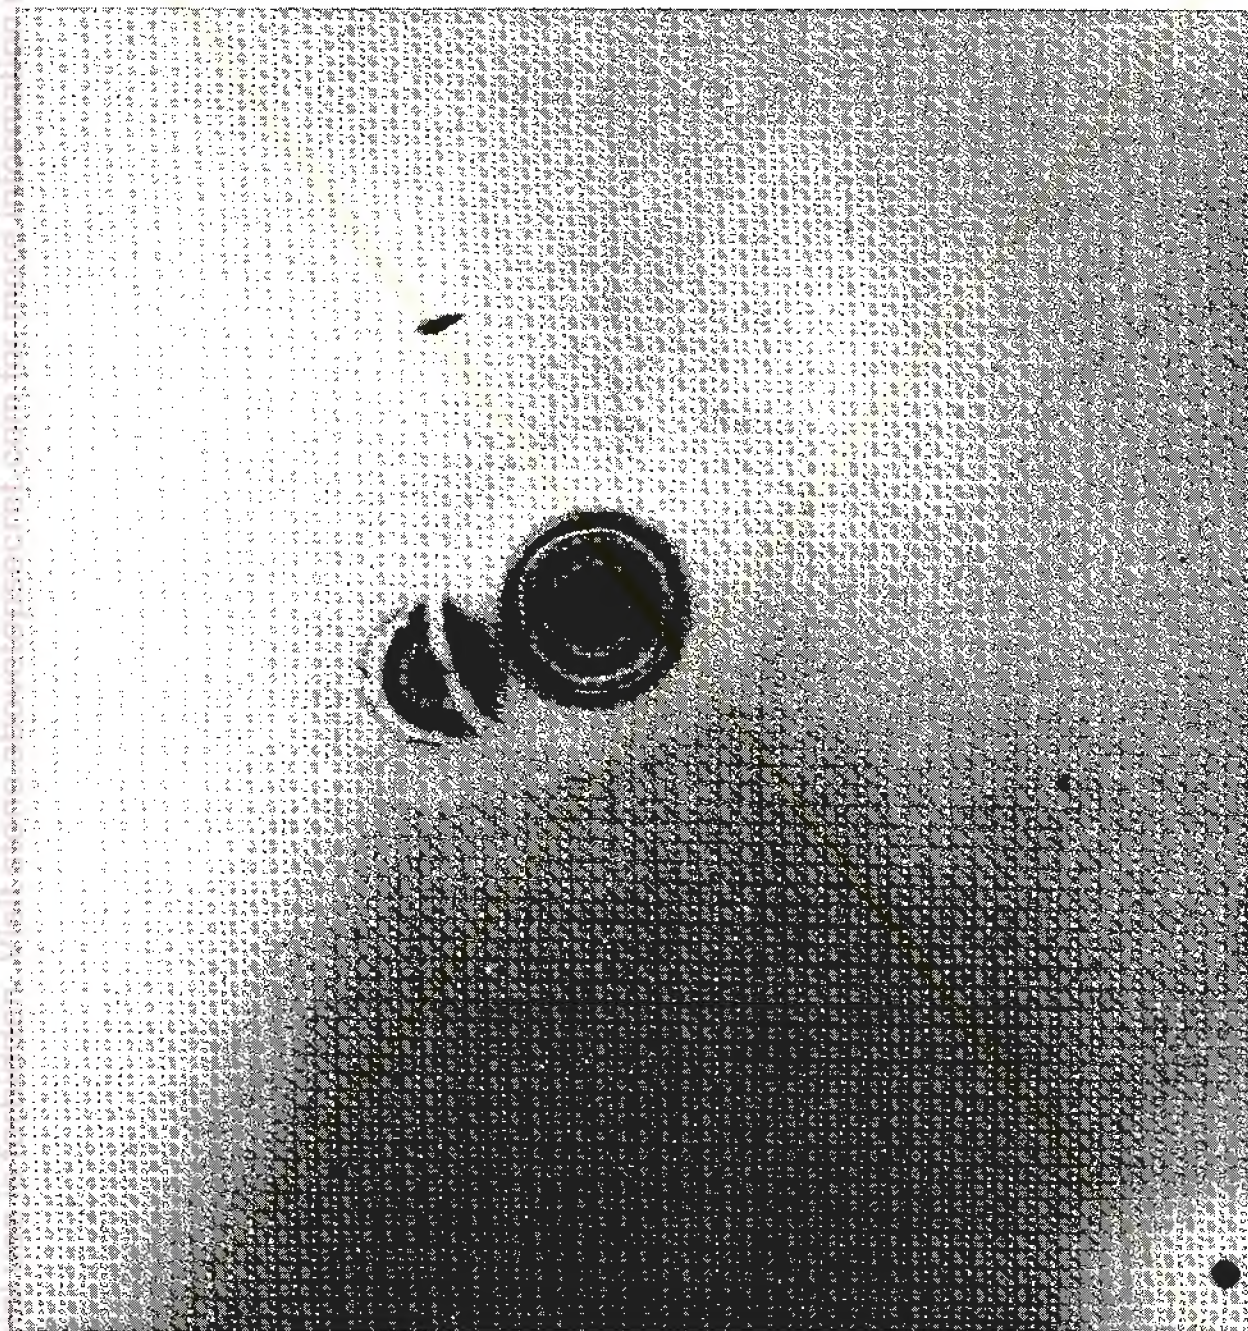
**Figure C11-2.** This is a pair of impact penetration features on the C11 thermal blanket, both with concentric rings. The rings of the smaller feature are incomplete, possibly related to the formation of the larger impact feature. View measures approximately 9 cm across.

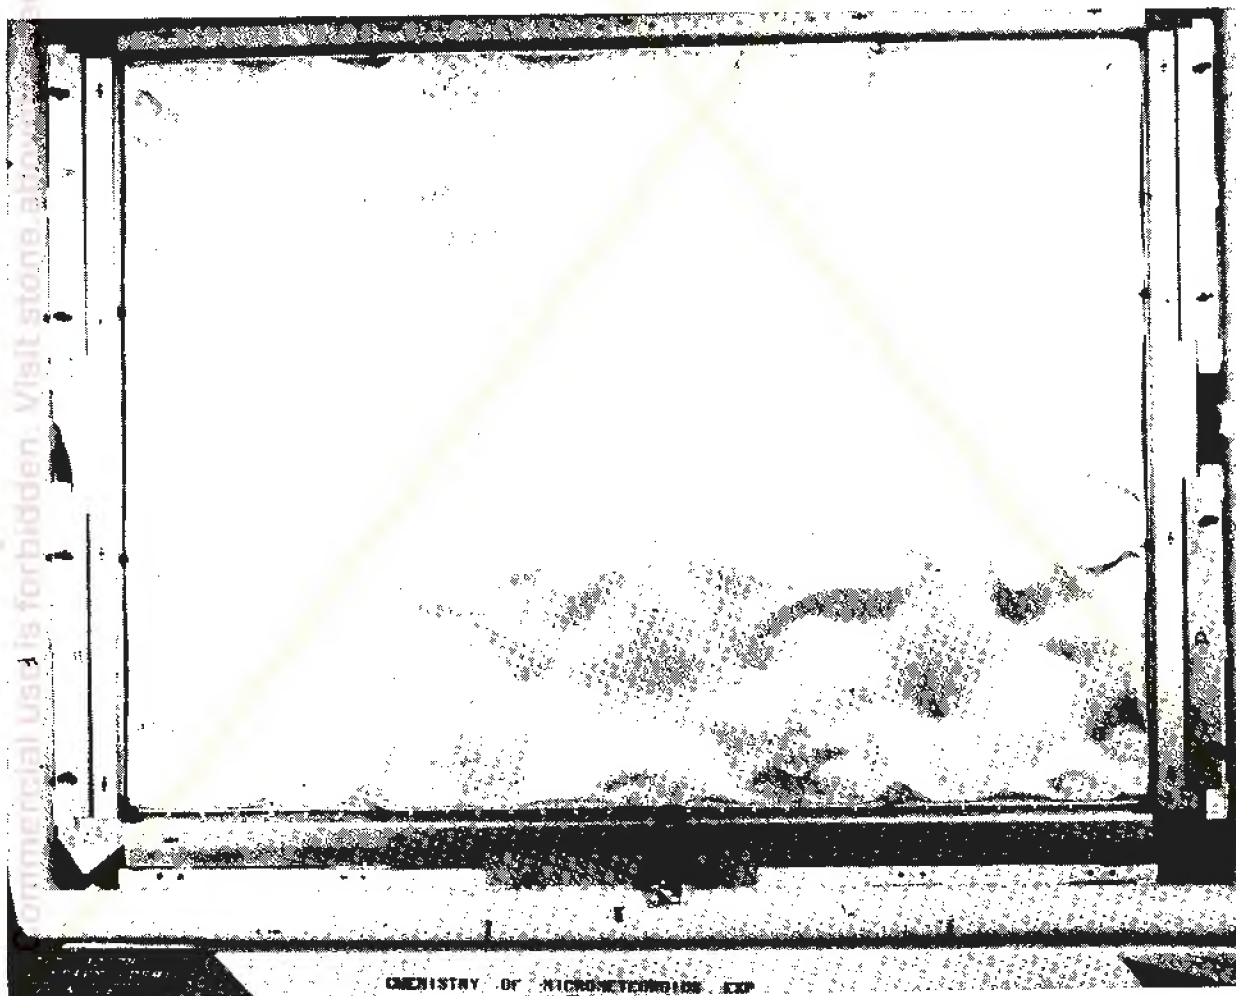
**Figure D11-1.** This post-deintegration view shows the front of the entire D11 experiment thermal blanket. Some impact features are apparent.

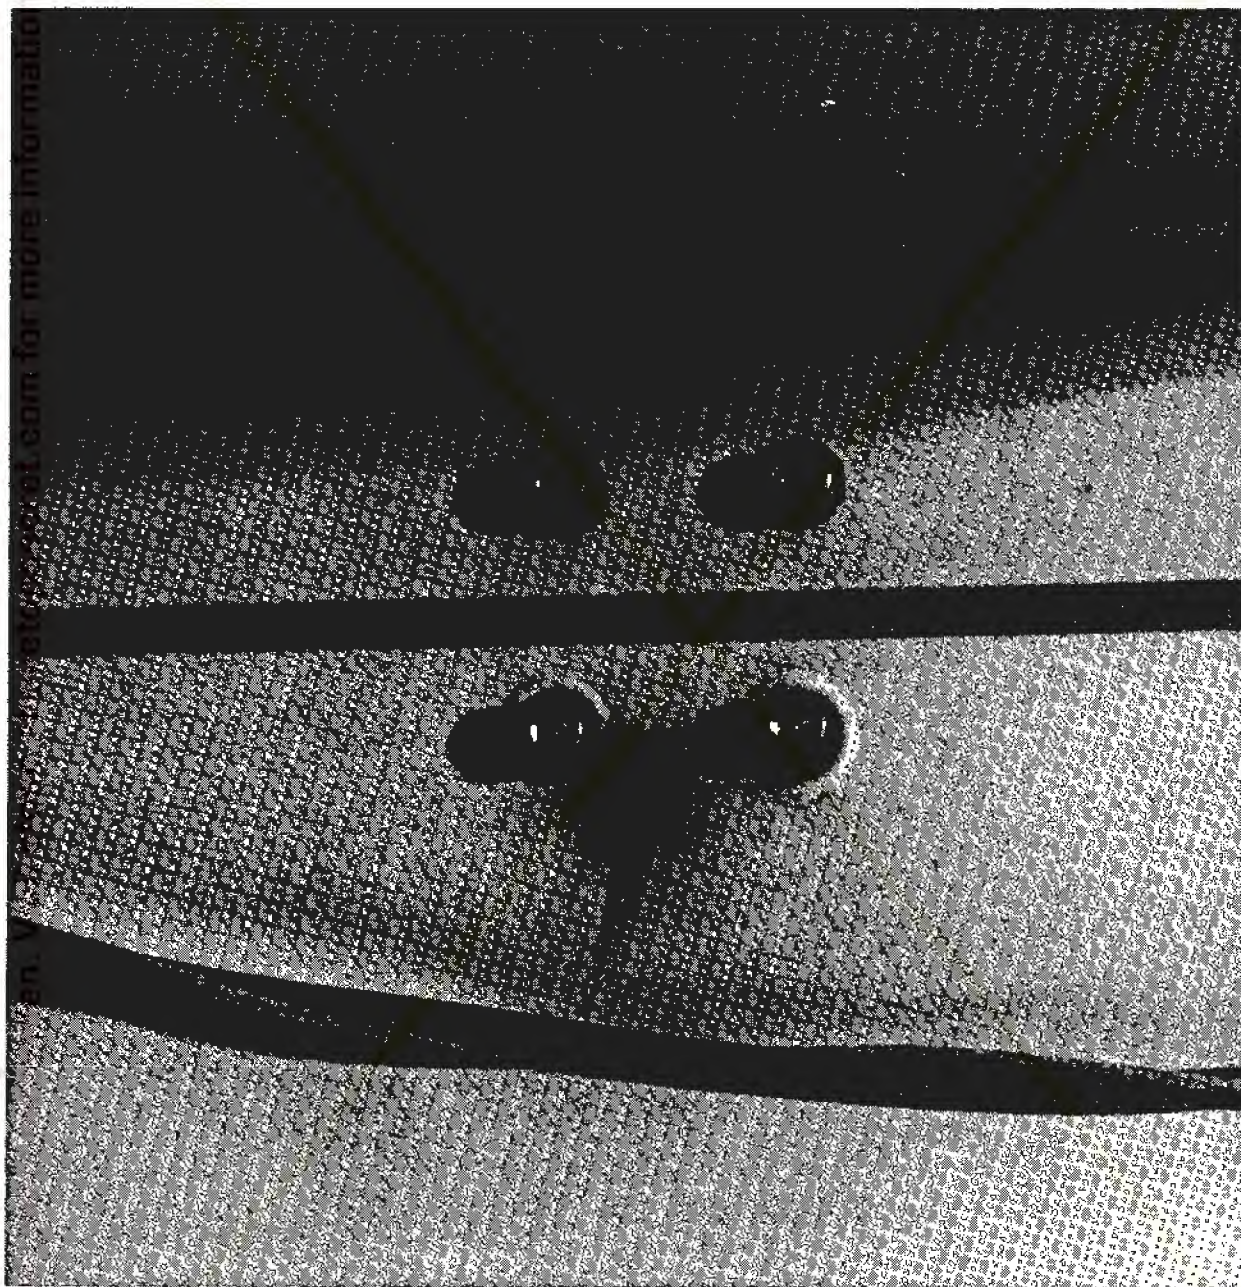
**Figure E12-2.** This view shows an ejecta spall pattern resulting from an impact (#8) into the lower left bolt head. View measures approximately 11 cm across.

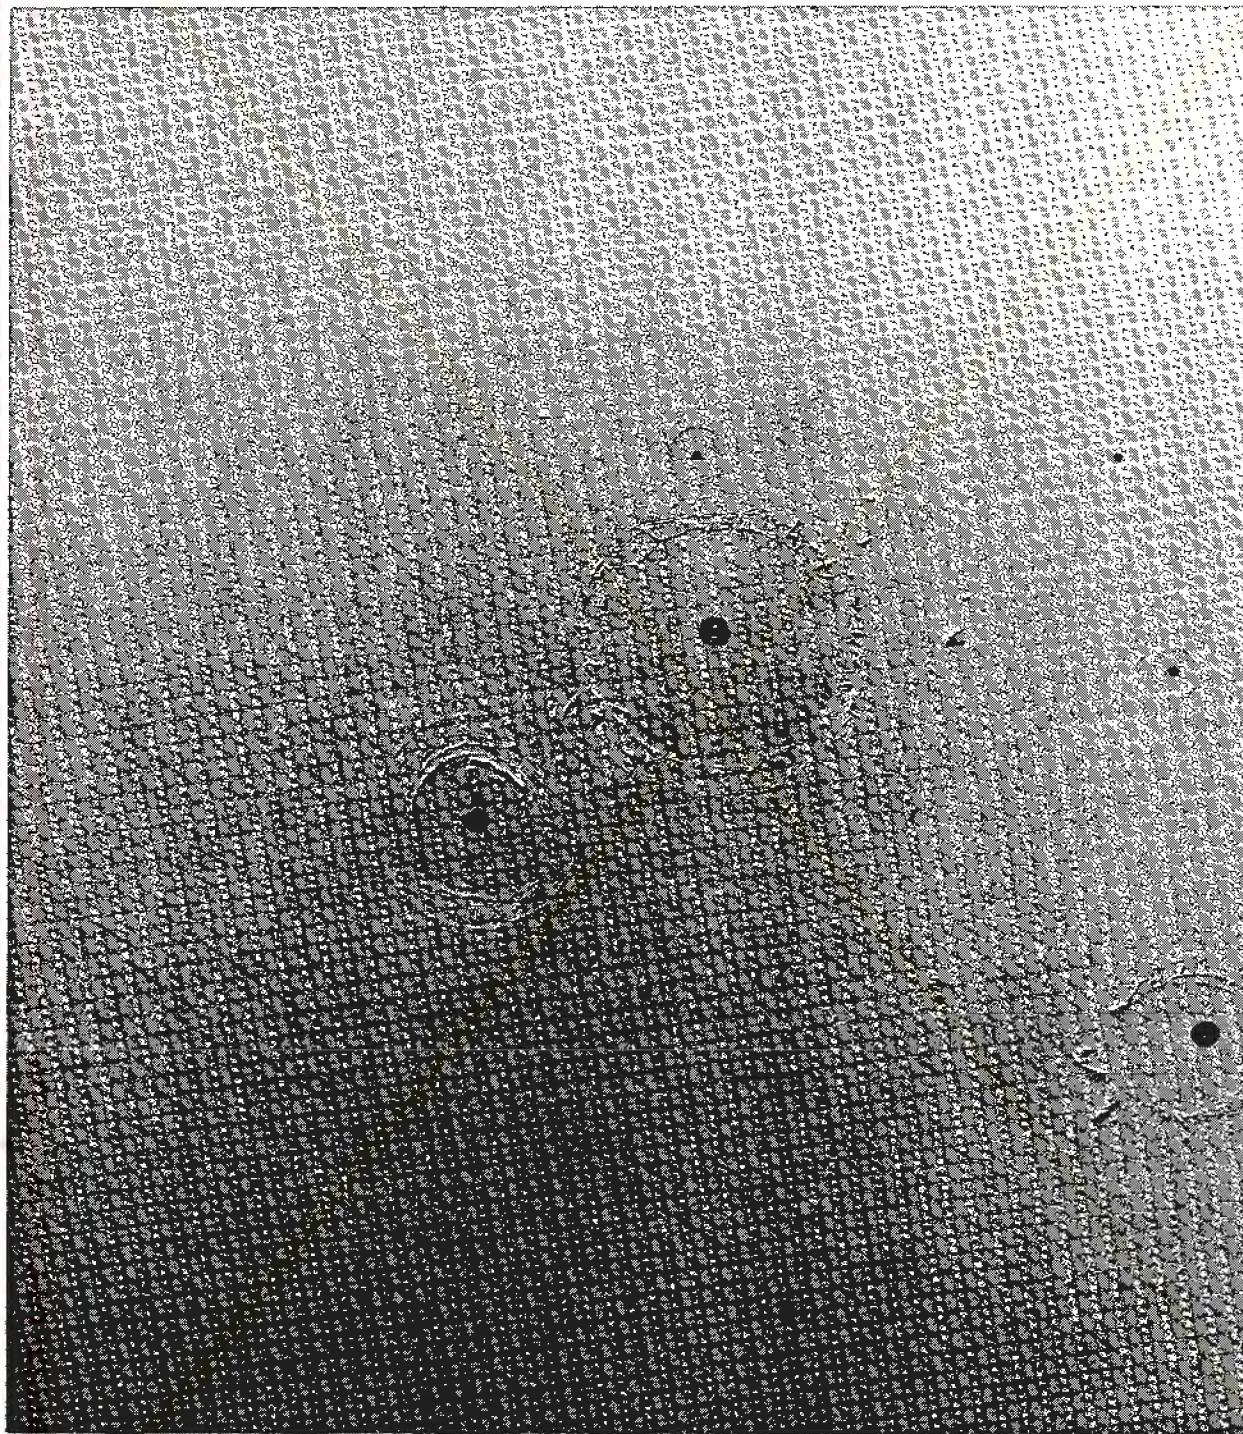
**Figure F08-2.** Impact features into the white-painted aluminum surface. Each crater extends through the paint into the aluminum substrate. Paint delamination features surround each impact. View measures approximately 8 cm across.

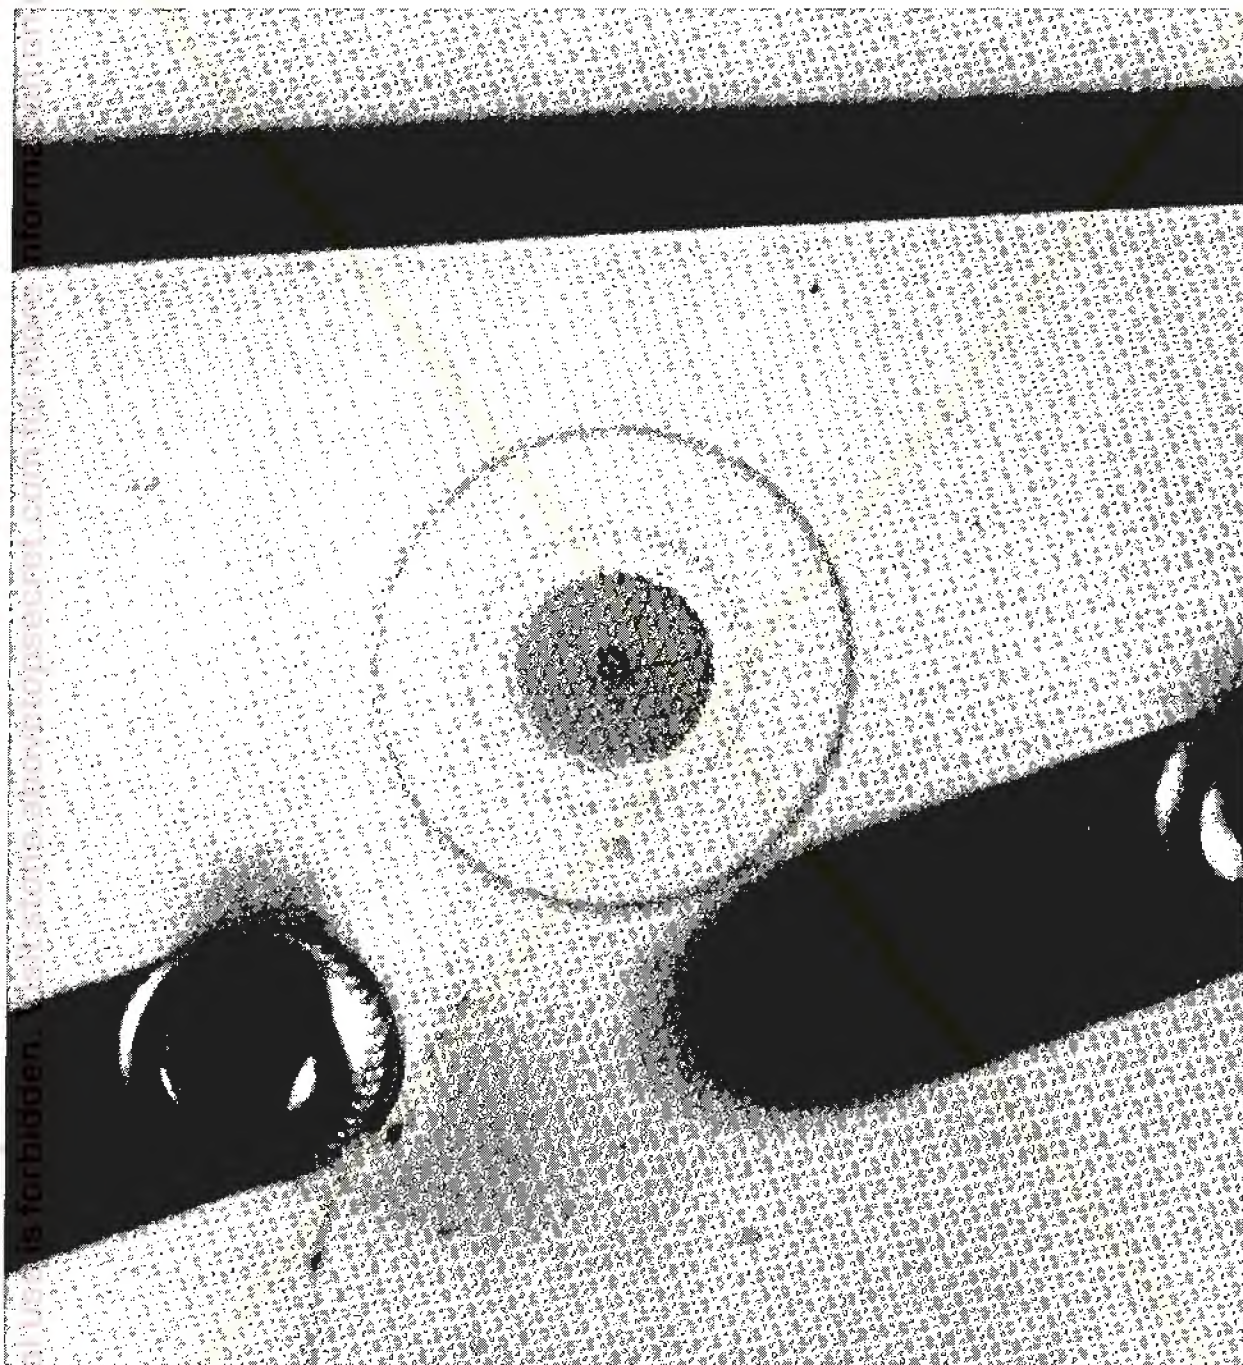
**Figure F08-3.** A concentrically-ringed impact feature into the white-painted aluminum surface. View measures approximately 4 cm across.

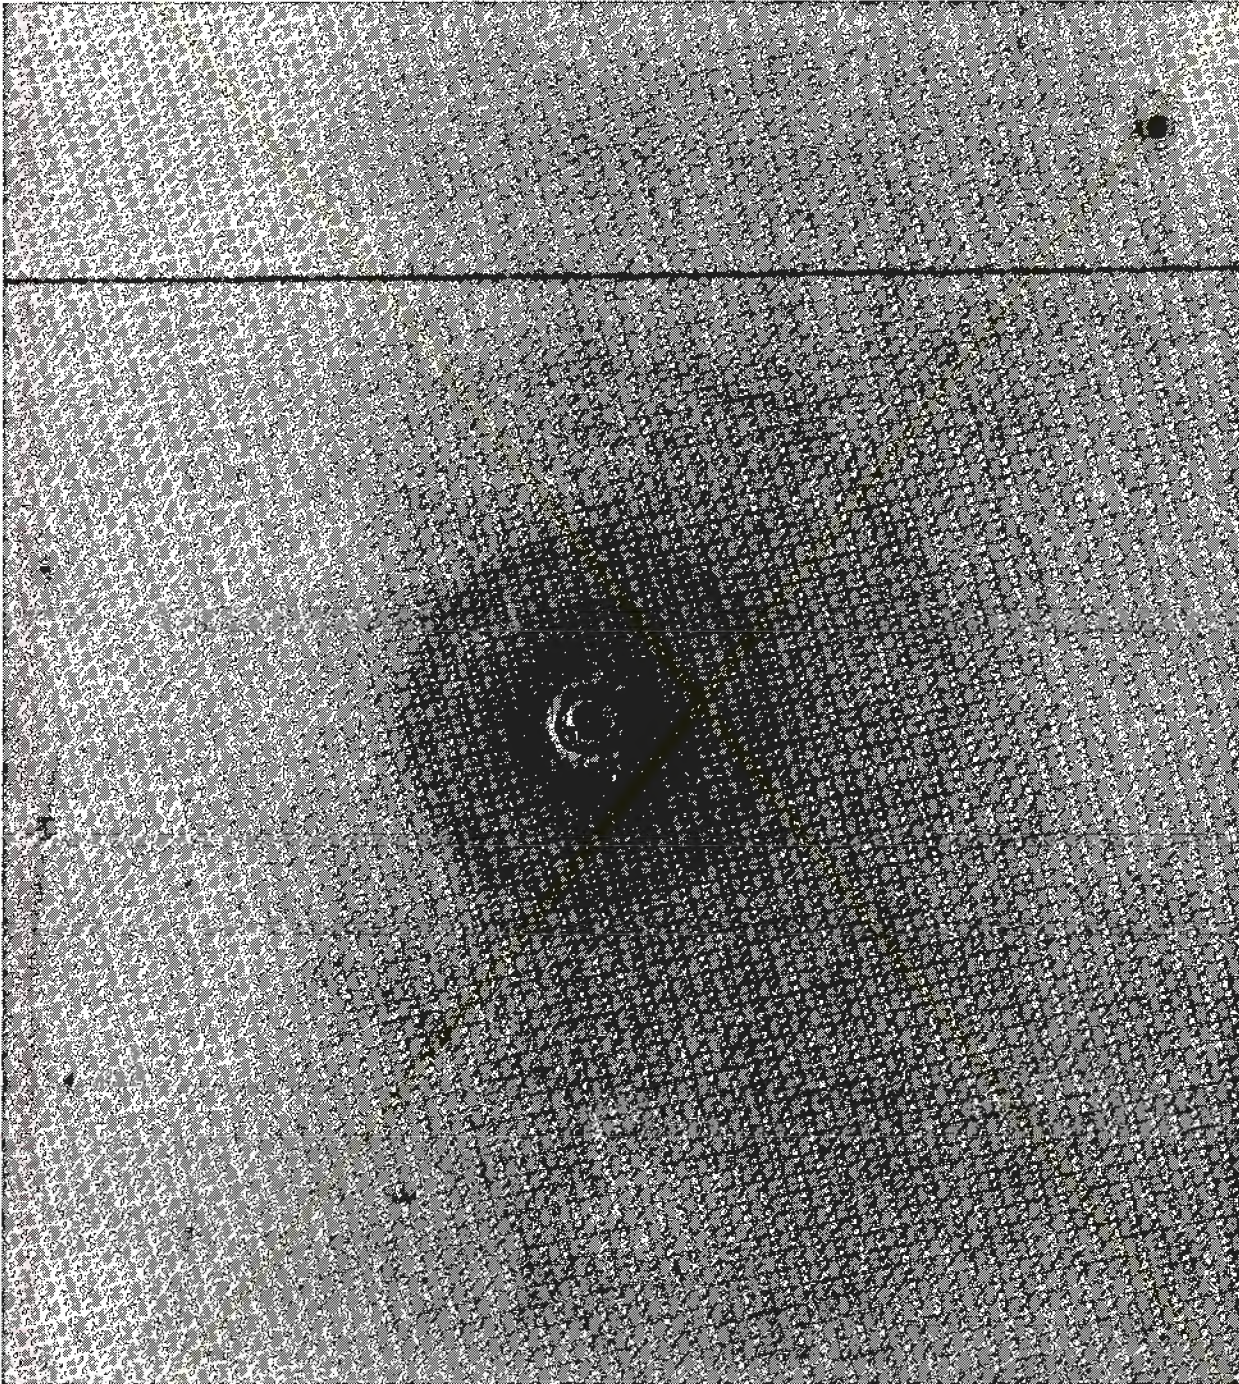
**Figure F09-2.** A concentrically-ringed impact feature into the white-painted aluminum surface. View measures approximately 8 cm across.

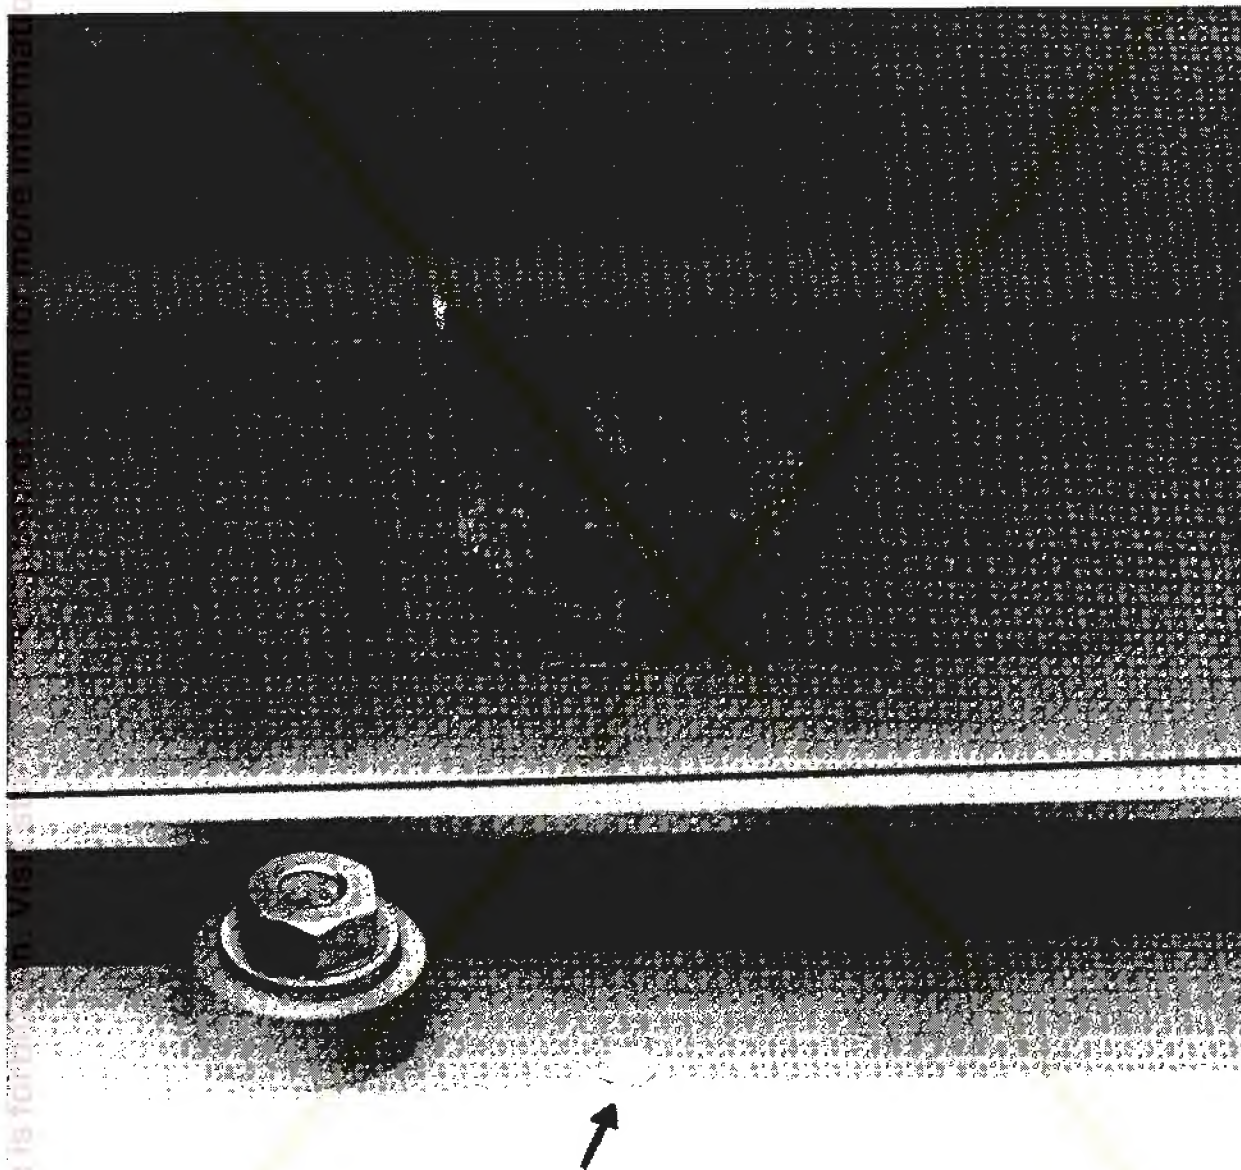
**Figure H09-2.** View of a crater (indicated by arrow) located in aluminum with a large adjacent ejecta pattern. The feature was located inside one of the detector housings. This view measures approximately 12 cm across.
